Manhole Inspection Summary

Manhole # S33AA1013MH

Insp Date: **3/5/07 11:09 AM**

Location Address: **3501 GREENWAY**

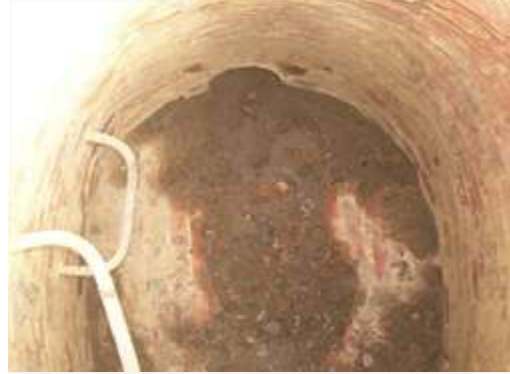
Top View

☒ **Debris** (not Condition related)

Channel debris.

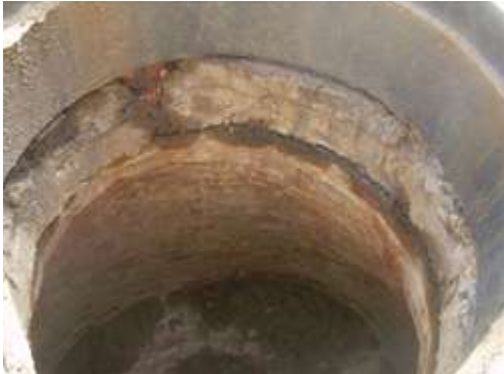
Defect

☒ **Leaks**

Condition: ☐ Sound ☐ Cracked ☐ Root Intrusion ☐ Loose Brick ☒ **Deteriorated**

Infiltration: ☐ None ☒ **Joint** ☐ Cracks ☒ **Mortar** ☐ Roots ☐ Wall

Infiltration: ☐ None ☐ Joint ☐ Cracks ☐ Mortar ☐ Roots ☒ **Wall**

Frame leaks. Adjustment deterioration and infiltration. Corbel and Barrel infiltration.

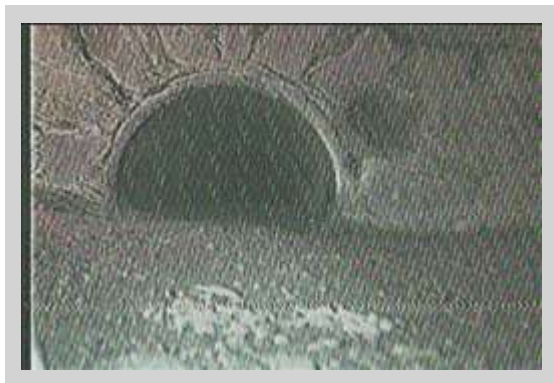
Pipe Out @ 12 O'Clock

Deposits: ☐ None ☒ **Mud** ☐ Sludge ☒ **Debris** ☐ Grease

Infiltration: **Evidence**

Pipe Seal Cond: **Cracked**
